Re: Eagle Lake Narrows Beach, Machar
Design Report

Eagle Lake Narrows Park and Beach is located between Eagle Lake Road and Eagle Lake within the Township of Machar. In 2023, Tatham Engineering Limited (Tatham) was retained by the Township to develop a solution to address ongoing erosion along the shoreline slope within the park. Following completion of design and tendering, construction of the shoreline protection works was carried out in Fall 2025.

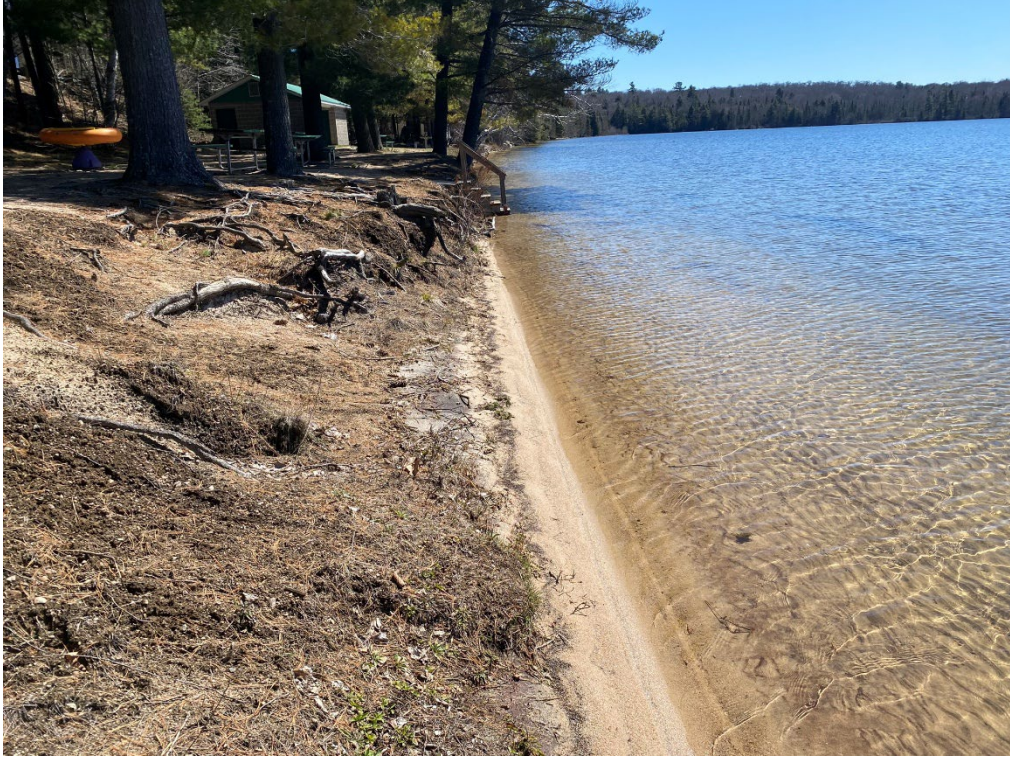
Figure 1: Exposed tree roots within shoreline slope.

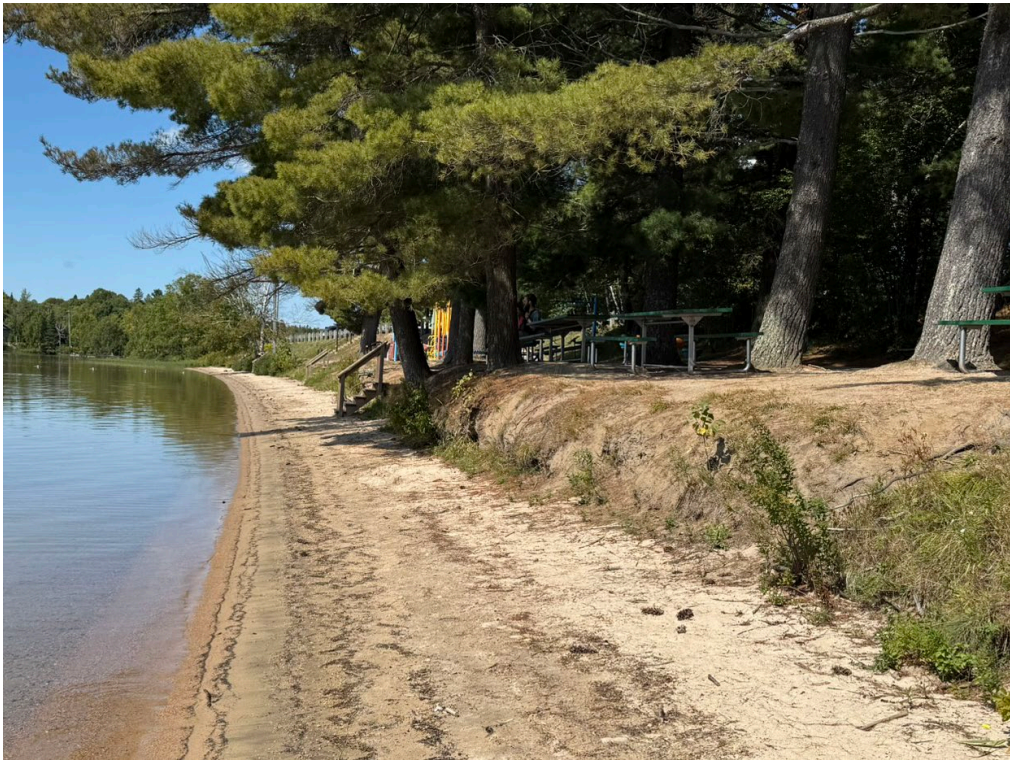
Figure 2: Leaning tree and erosion of toe of shoreline slope.

The erosion resulted from a combination of uncontrolled drainage from Eagle Lake Road, wave action along the shoreline, and fluctuating lake levels. These processes contributed to ongoing slope deterioration and increased risk to park users and adjacent infrastructure.

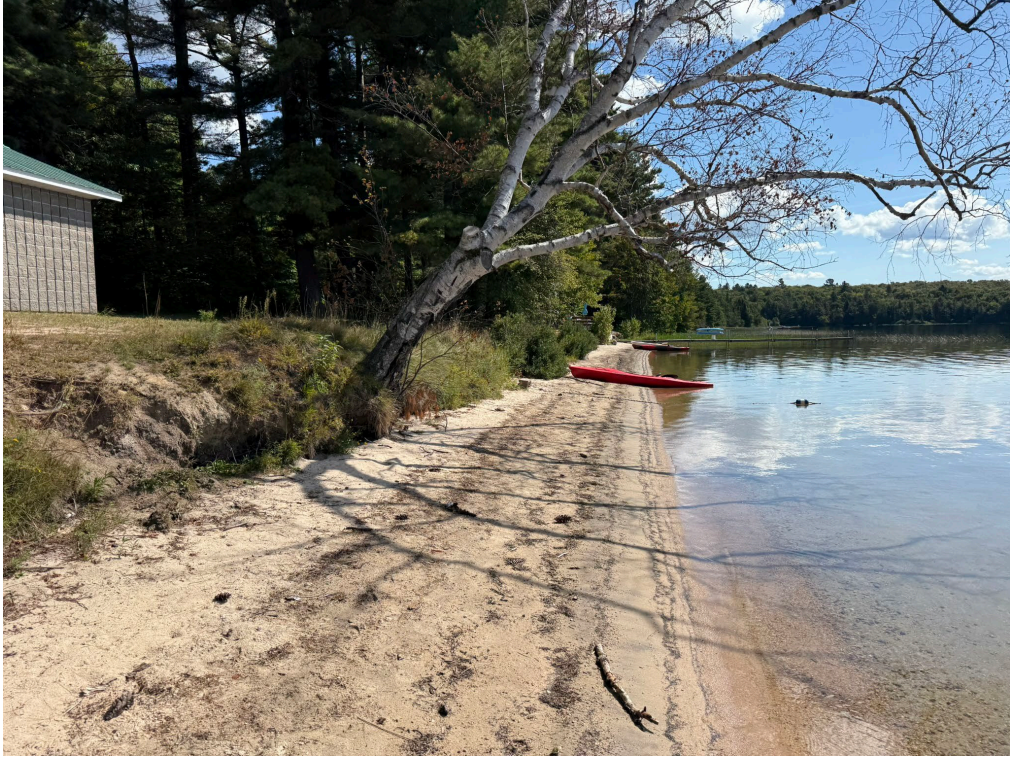
Figure 3: Shoreline erosion and compromised tree within slope.

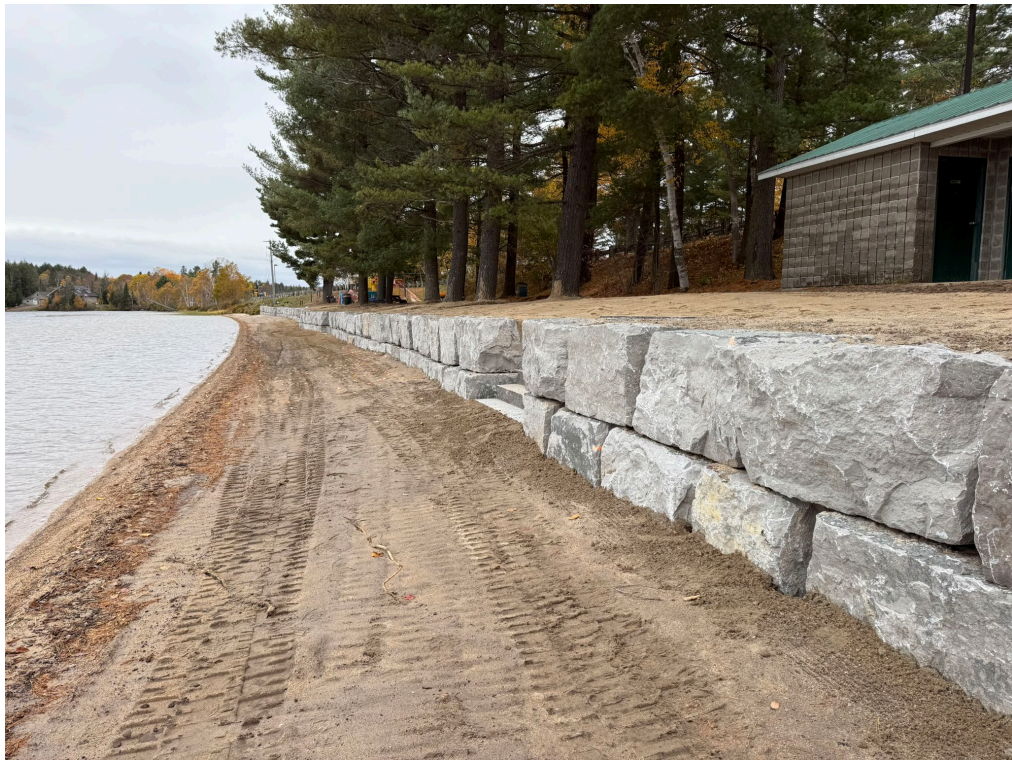
Figure 4: Constructed armour stone shore wall.

The preferred alternative consists of an armour stone retaining wall founded on a prepared granular base with geotextile separation to prevent soil migration while allowing drainage. Granular backfill and subdrainage provisions have been incorporated to manage groundwater and reduce hydrostatic pressures acting on the structure. The design maintains the existing top and bottom of slope elevations, such the overall slope height remains unchanged.

The wall ties into the existing grades at the top and bottom of the wall and is finished with a sand cover to match adjacent beach conditions.

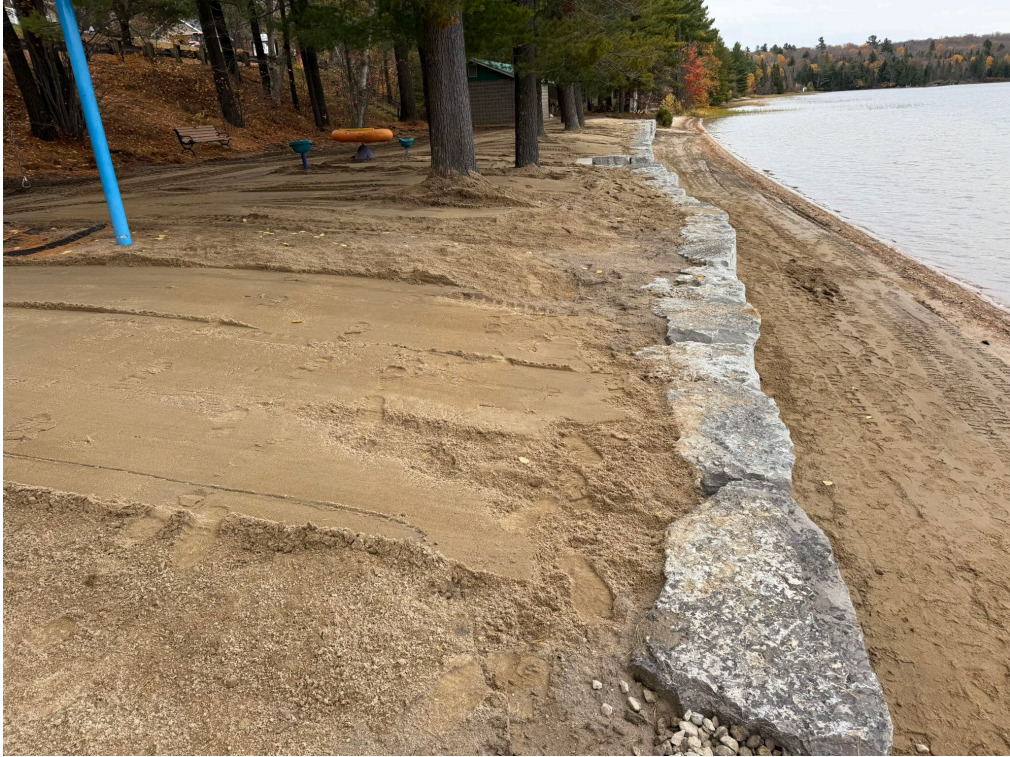
Figure 5: Minor adjustment to wall alignment to accommodate tree root systems.

Tree removals were limited to those already significantly compromised by erosion. Where feasible, stable trees were retained through minor adjustments to the wall alignment. Tree removals and root impacts were assessed in the context of existing site conditions, including exposed and undermined root systems. The works improve slope stability and reduce ongoing erosion and root exposure relative to pre-construction conditions.

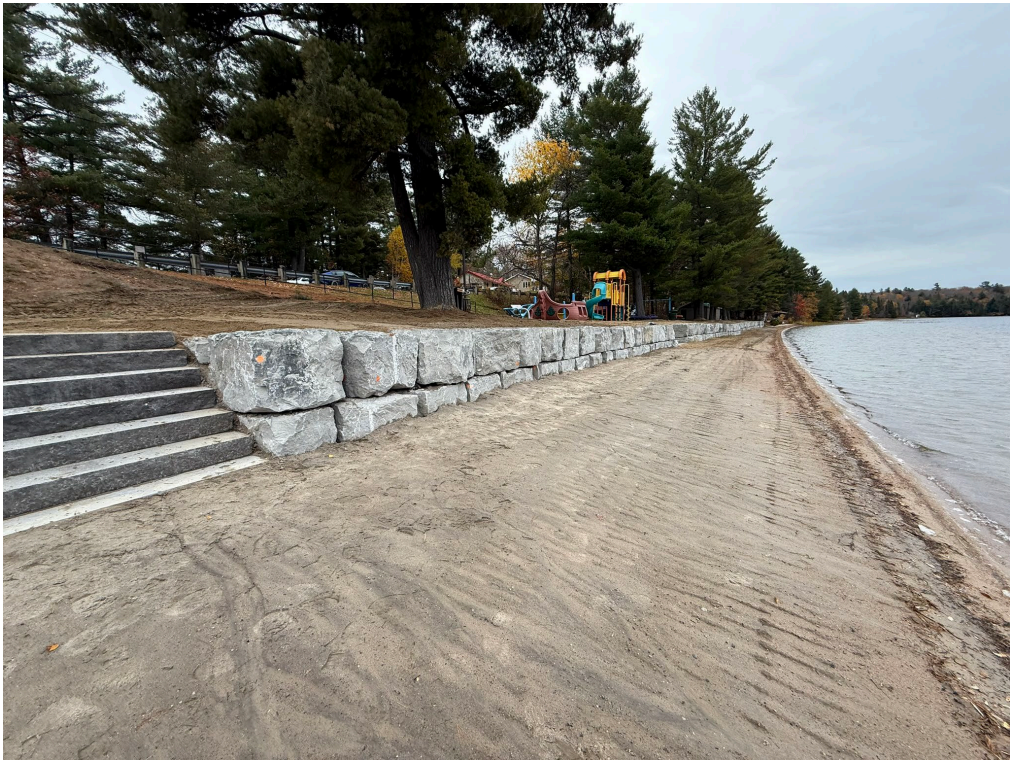
Figure 6: Stone step access to beach.
